Vantage Pointe Condominium Corporation

Plan No: 071 0813

Address: 1035, 10th Avenue SW, Calgary AB

2017 Capital Replacement Reserve Fund Study

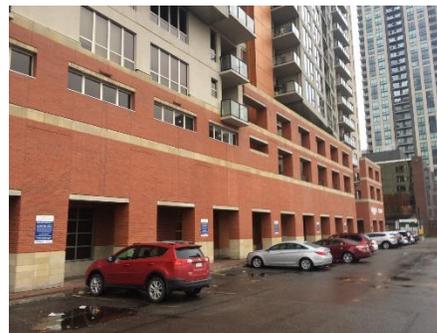
The complex is also clad with brick veneer, which appeared in good condition at the time of our review. Minor staining and cracking of the mortar was noted, however did not appear to be a concern and full replacement of the component is not anticipated within the timeframe of the study. The brick wall assemblies utilize the rainscreen approach for moisture management. The rainscreen approach to controlling environmental loads is based on the principle that moisture penetration through the exterior surface of the building envelope is inevitable over the life of building. The system uses multi-layer seals (primary seal through surface drainage and secondary seals within the cladding) and purpose built drainage cavities to capture and discharge incidental moisture that bypasses the exterior cladding surfaces back to the exterior. A partial restoration budget for repointing of joints and select brick/stone unit replacement is included in the study.

Photograph 4: Brick cladding.

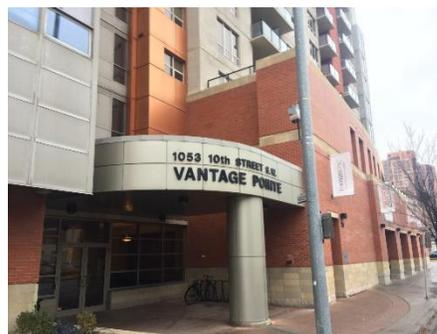
Photograph 5: Metal Panels and Awning.

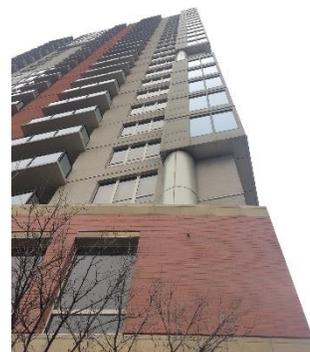
Photograph 7: Metal Panels.

Metal cladding/trim panels appeared to be in good condition and eventual replacement has been included, as potential corrosion of the metal panel and/or anchors may occur. Depending upon the desire to update appearances, the Board and owners may wish to consider repainting/finishing the panels on a regular basis to maintain the surface integrity of the coating prior to replacement. We have included a partial repainting budget within the reserve fund study.

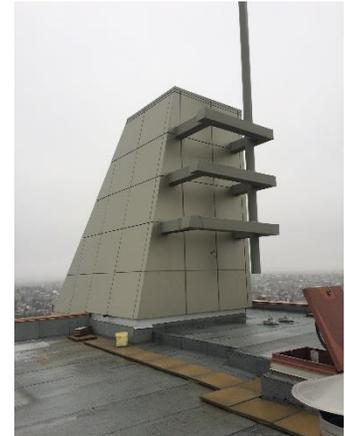
Photograph 8: Penthouse Cladding.

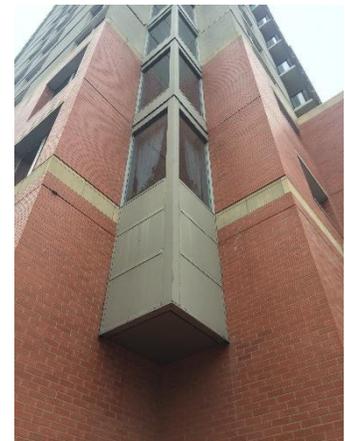
Photograph 9: Building Envelope.

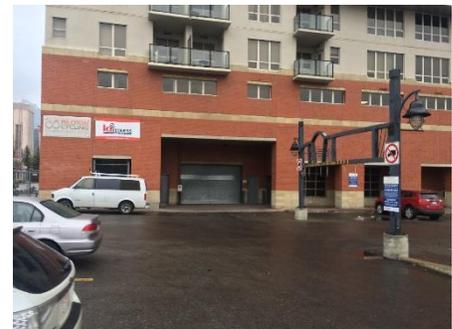
Refuse/loading dock doors have been included in the study and the expected service life will highly depend on the frequency of use and level of maintenance on the individual door. Costs include both the door panels and motor replacement, additional funds will be required if the frame and hardware components are to be replaced in conjunction with the door.

Photograph 10: Refuse Doors.

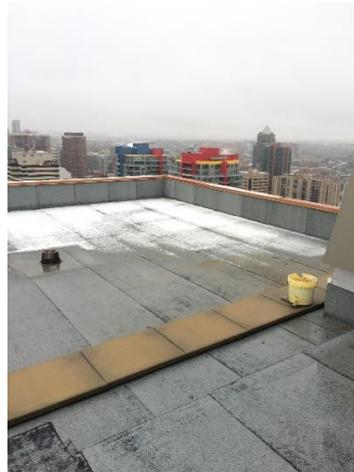
Photograph 11: Penthouse Roof.

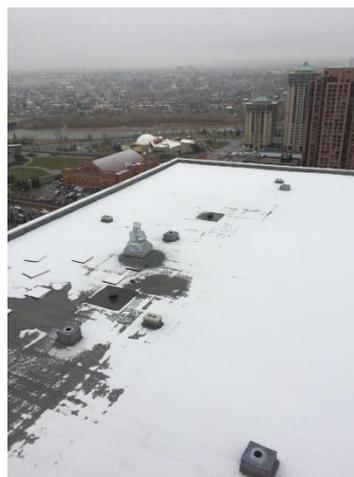
Photograph 12: Tower Roof.

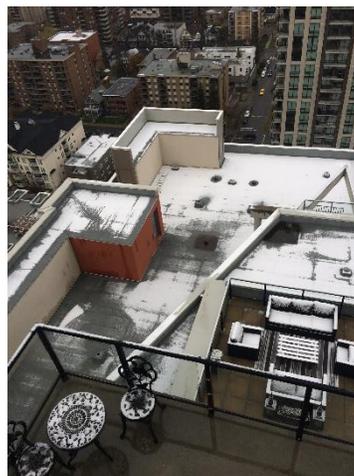
Photograph 13: Roof Top Patios.

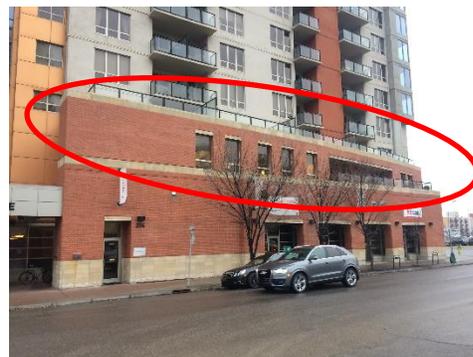
We understand that isolated areas of roof damage and parapet damaged occurred in 2016 during a high wind event and that repairs have been scheduled for the summer of 2017. Parapet restoration budgets have been provide in the previous section while we have included an allowance for restoration of the roof assembly below. These budgets should be considered preliminary and further adjustment may be required pending full review/tendering of the scope of work to contractors.

Photograph 14: Second and Third Floor Roof Assemblies (section).

We recommend performing annual roof inspections as part of a preventative maintenance program and that the remaining life of the roofing be revised based on the results of the review and maintenance requirements. If any evidence of moisture infiltration is identified, remedial repairs should be initiated promptly to mitigate damage. Preventative maintenance measures should include cleaning and removal of debris from drains, sealant application to open joints or failed seams,

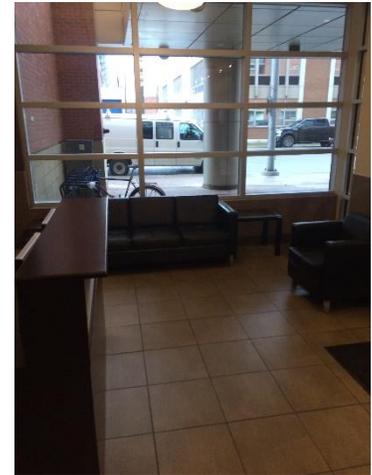
Tile finishes located throughout the lobby and hallway floors appear to be in good condition at the time of our review. The frequency of future replacement will depend on the Corporations desire to update appearance and wear in high traffic areas. Replacement costs will vary depending on the replacement tile selected.

Photograph 15: Lobby.

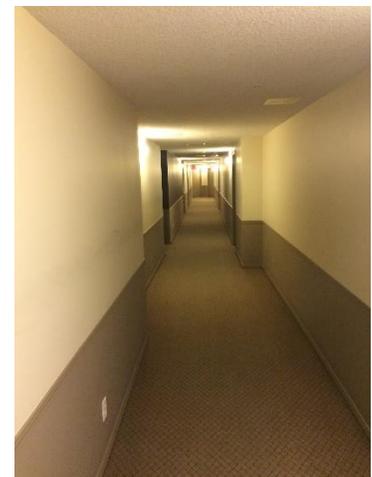
Photograph 16: Hallways.

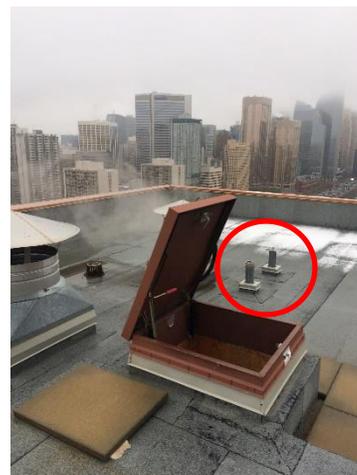
Photograph 17: Tieback Anchors.

The building is equipped with a tieback anchor system to safely provide exterior access to the tower. The steel components should be inspected and certified on an annual basis. Annual maintenance may be required depending on the level and type of use. Full replacement of the system is not anticipated within the time frame of the study; however we have included a restoration allowance to address isolated waterproofing and possible select steel replacement.

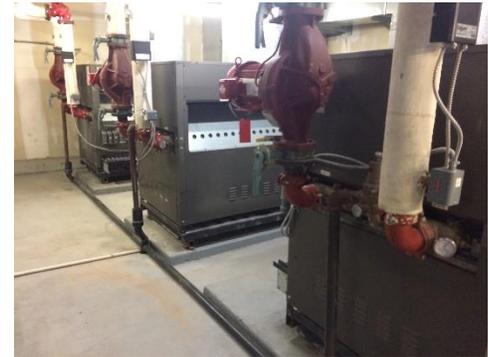
Photograph 18: Boilers.

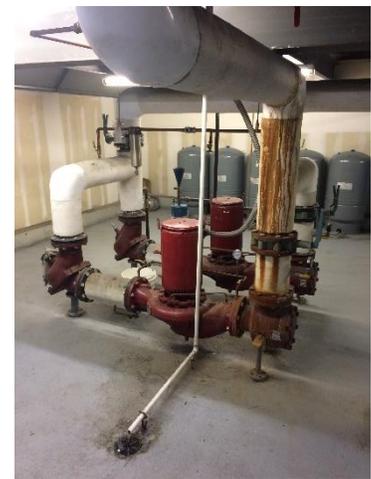
Photograph 19: Pumps.

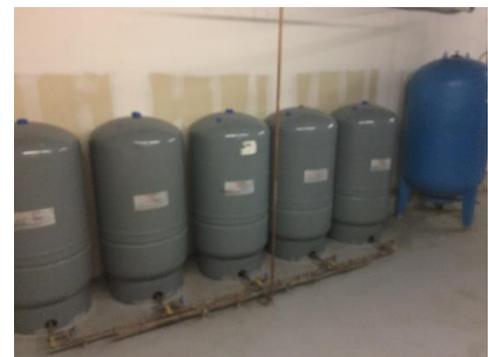
Photograph 20: Cushion Tanks.

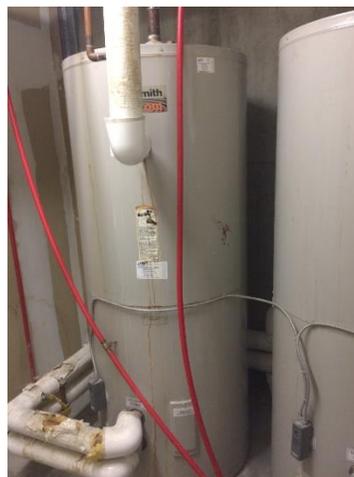
Photograph 21: Hot Water Tanks.

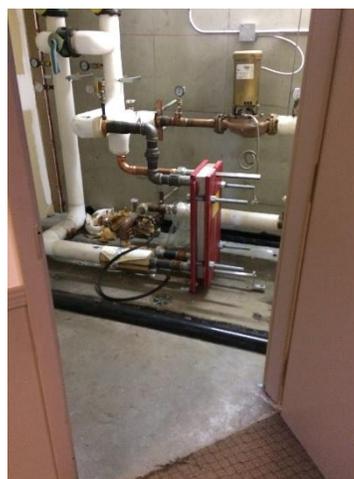
Photograph 22: Plate to Plate Exchanger.

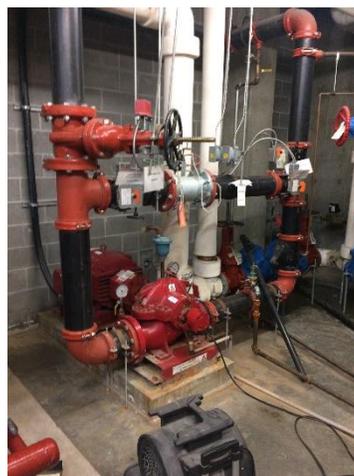
The domestic water piping was noted to be copper, brass valves, and copper risers/ distribution to the residential

Photograph 23: Water Piping.

Isolated leaks in both the heating piping and water piping should be repaired on an "as needed" basis, however replacement should be considered when it is more economical than select repair. Monitoring and recording locations and frequency of pipe leaks will help to determine when a replacement program should be implemented. Ultra sonic testing, to determine the existing pipe wall thickness in localized areas, could be completed in the future and would assist in scheduling the replacement. The actual timing of the replacement and costs will be influenced by factors such as the quality, quantity and configuration of the piping and its installation and the quality of interior finishes that will be affected during the work. The timing of the replacement of the piping will be a function of the rate of failure that occurs in the piping.

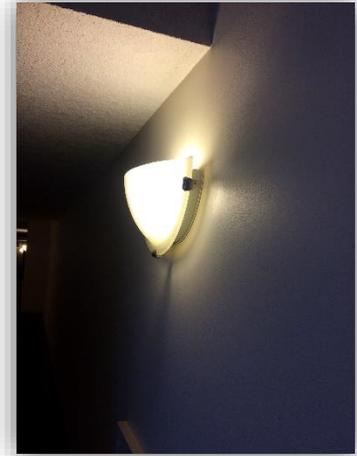
Photograph 24: Interior Lighting.

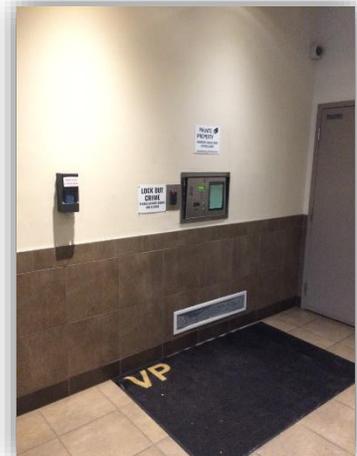
Photograph 25: Intercom.

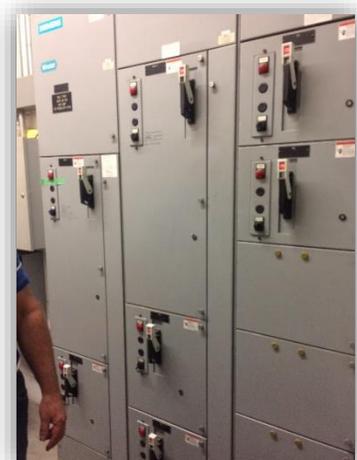
Photograph 26: Disconnect.

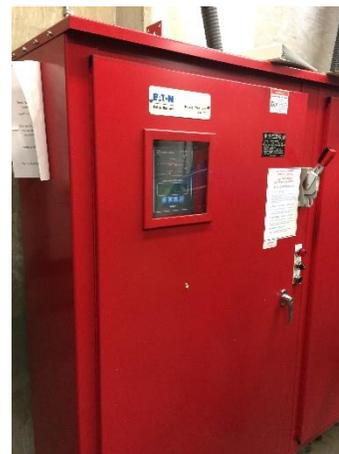
Photograph 27: Fire Jockey Pump/Panel.

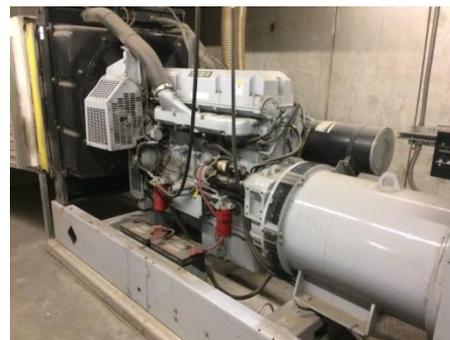
Photograph 28: Emergency Generator.
